AEROSPACE REPORT NO.
TR-93(3478)-1

Investigation of ACC/CCI Tunnel Diodes

In October of 1991, a DMSP radio-frequency detector in channel T2 of system B6 failed during testing. The detector module exhibited low output. Subsequent investigation initiated by Aerojet, the DMSP prime contractor, traced the problem to the tunnel diode in the detector. Tunnel diodes are used in a number of low-power microwave applications. The tunnel diodes are manufactured by Custom Control Components (CCI), and the detector modules by Advanced Control Components (ACC). Although ACC and CCI are separate companies "on paper," they share the same manufacturing facility and are not readily distinguishable by the casual observer. Destructive physical analyses carried out after the failure indicated that contaminants had been introduced during fabrication. Site visits at ACC/CCI by contractor and Aerospace personnel led to a general improvement of the manufacturing process with a concomitant improvement in detector reliability. A review of the available literature pointed to a tunnel-diode failure mechanism found some years ago by researchers at Comsat and led to a recommendation of an additional component

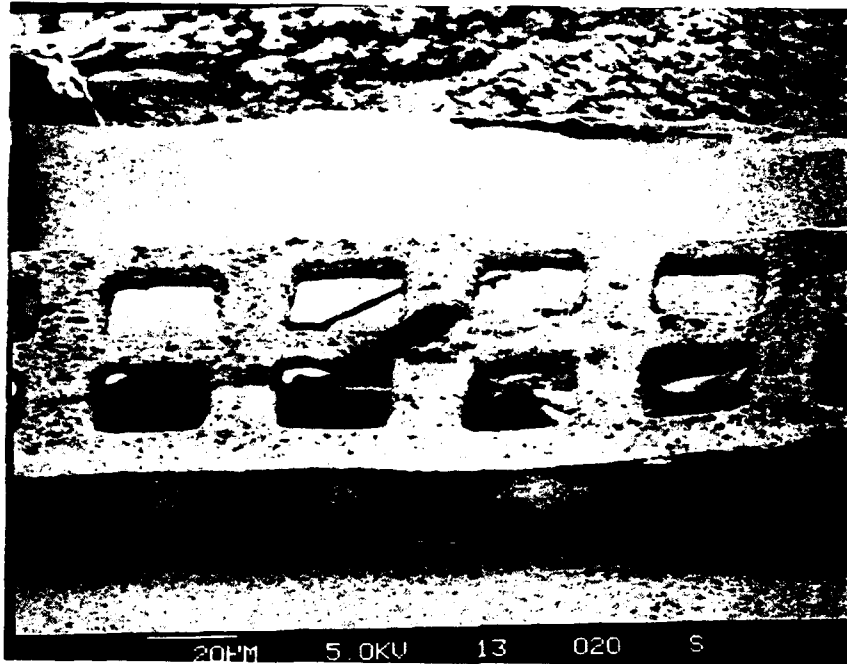
Figure 14a. Epoxy contamination appears as both dark areas on top of mesh ribbon and as bright areas (because of effects of charging) on sides and beneath ribbon (NASA device, S/N 113, 600 \times magnification).

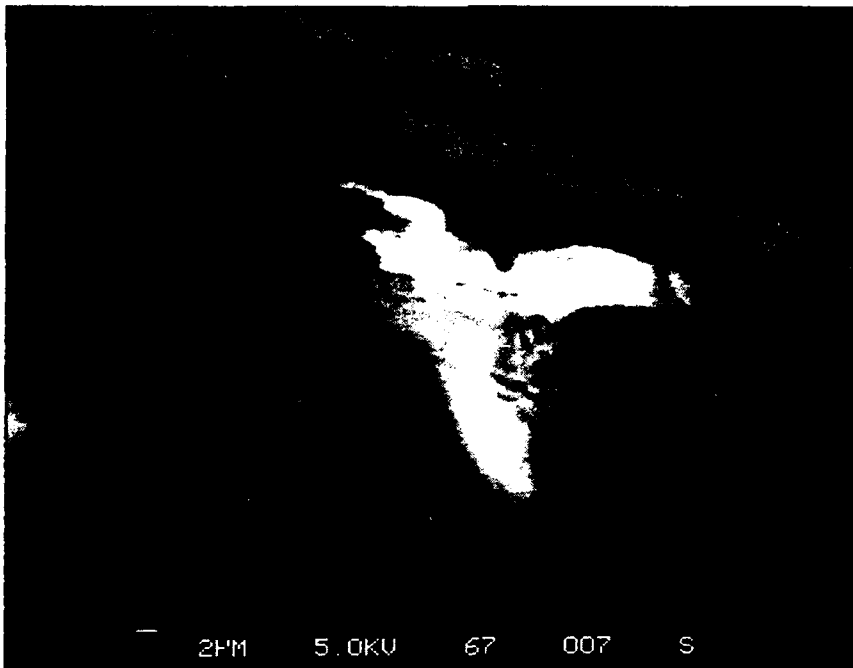
Figure 16b. Note complete coating of the mesa by epoxy (NASA device, S/N 167, 1000× magnification).

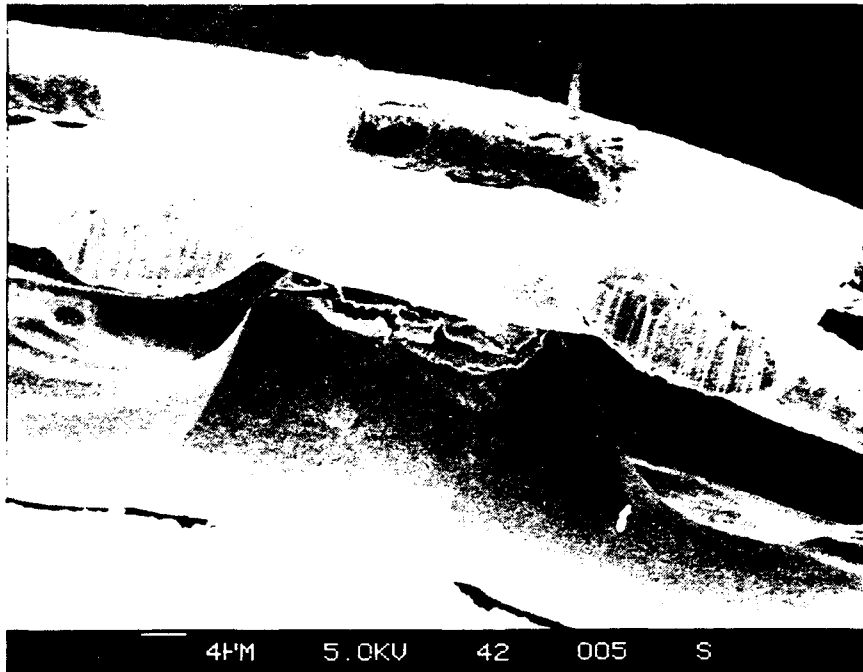
Figure 20b. Mesa region. The Ge has fracture (NASA device, S/N 142, 2000 \times magnification). No "stalk" evident.

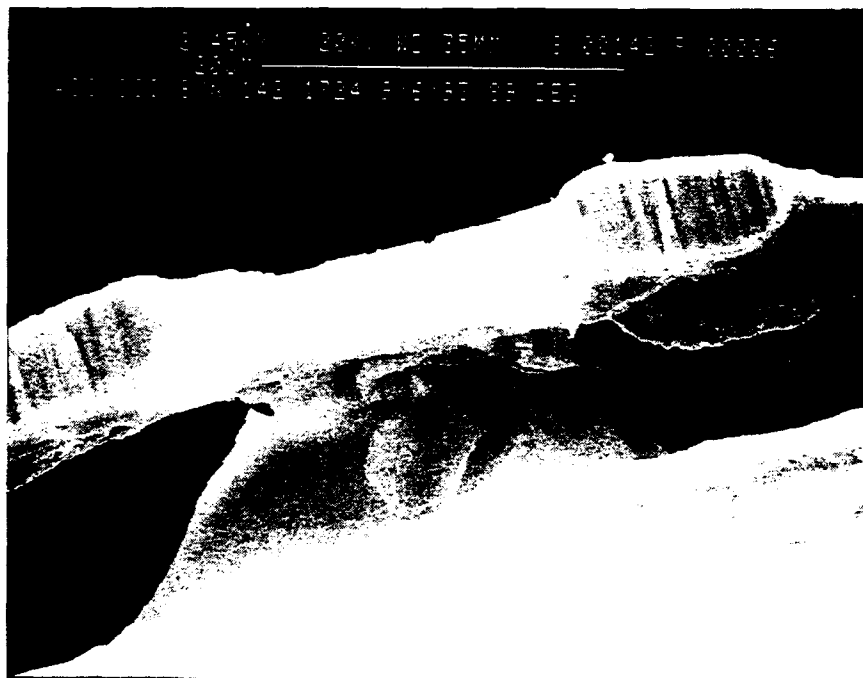
Figure 21b. This is the other side of the "mesa" (see Fig. 20b) (NASA device, S/N 142, 2450 \times magnification). Still no evidence of a "stalk."
